PROJECT PROFILE

Improving Grid Resiliency with the Tough Truss Core®

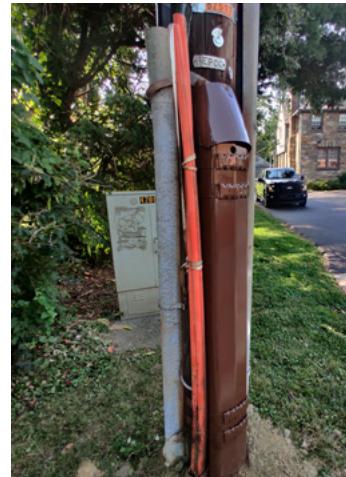
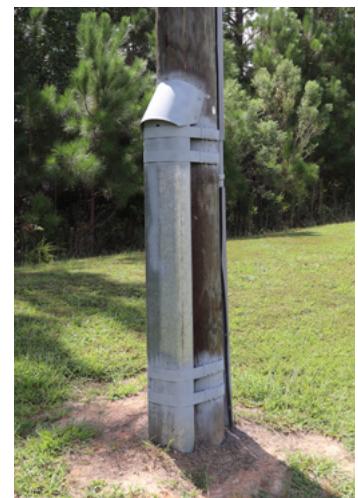
The newly designed and patented Tough Truss Core offers a distinctive cross-section with inward-formed legs, adding strength in all bending directions while improving its fit to the wood poles it restores. Because this new design can be used universally with more orientation options on the pole, utility crews spend less time and resources preparing a range of truss sizes needed for the job from anticipating the variety of obstacles they could face.
