## PROJECT PROFILE

### Cyclical Assessment Program

**Cyclical assessment yields improved safety, reliability, and excellent return on investment**

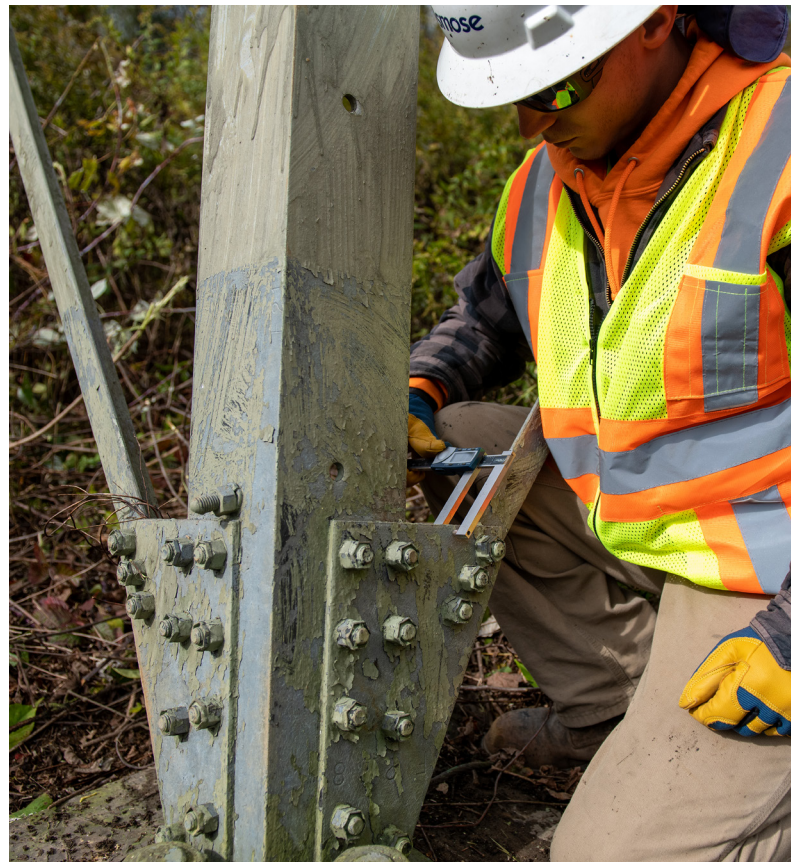
A utility in the Southeast initiated a pilot assessment project to determine the below-grade condition of their transmission system, which included more than 40,000 steel structures. This pilot assessment included the excavation of 240 towers, which revealed evidence of below-grade corrosion far more severe than anticipated. It was determined that one-third of the towers displayed heavy corrosion and would require restoration. The utility decided that a cyclical, comprehensive inspection program would provide the greatest long-term protection and extend the service life of the assets. The cyclical inspection program included a full excavation of each tower's foundation and the application of protective coatings.

Osmose's recommended assessment and mitigation program consists of a full 18 to 24 inch excavation, where deterioration is most likely to occur, and a comprehensive structural assessment of each tower member in the deterioration zone. Additionally, several environmental tests are performed on the surrounding soil, which allows the likelihood and severity of future corrosion to be determined. Structures are categorized based on specific criteria of the selected corrosion rating system. In this utility's case:

- Tower legs categorized in Condition A and Condition B received a protective coating to mitigate further corrosion
- Tower legs rated as Condition C, Condition D, and Priority received engineered restorations. In addition to the restoration, the affected tower legs received protective coatings to prevent the on-set of future corrosion.

Of the 1,034 steel towers and poles that were assessed in that year, 778 towers were coated and required no further action. This included 439 towers listed as Condition B (moderate corrosion) which, without assessment and coating, would have migrated into Condition C (significant corrosion and 10-25% section loss) and eventually Condition D (severe corrosion) requiring restoration in the coming years. Assessing and coating those 778 towers that same year, versus potentially restoring 439 of them in the future, saved the utility more than \$2.9 million in restoration costs.

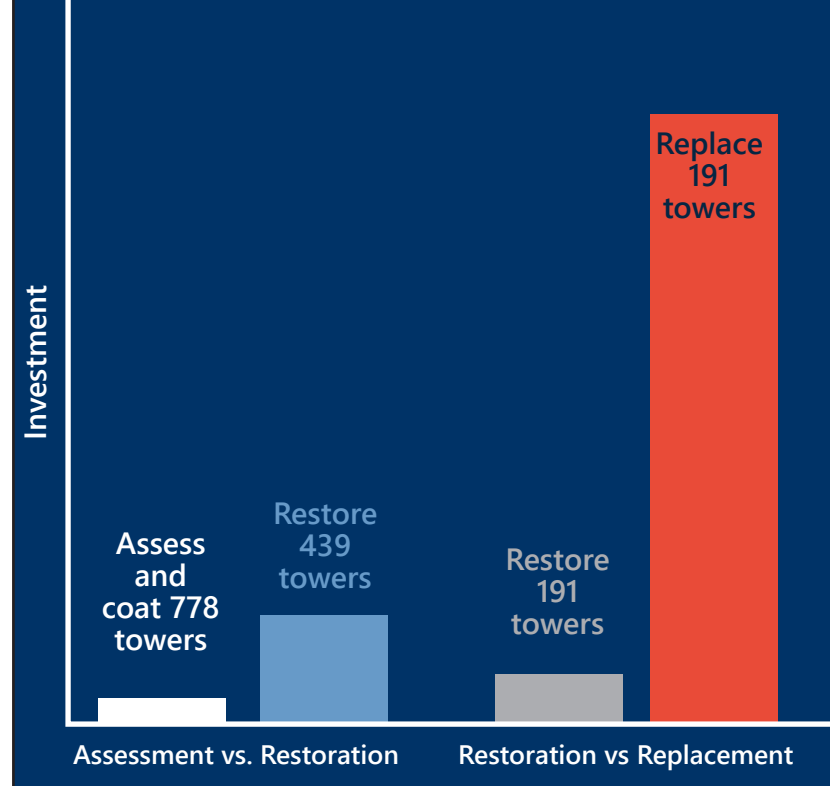
This utility's network of transmission structures is comprised of different tower types, with each

requiring a specific restoration. Osmose standard restorations are designed to meet structural loads that account for line angle, environmental conditions, and post leg capacity for each specific structure type. These rehabilitation solutions are designed to meet American Society of Civil Engineers (ASCE) standards to restore original strength and increase capacity when greater strength is required. This structure-specific restoration approach reduces the need for costly, heavy equipment at each structure site and is extremely cost effective when compared to replacement. Most importantly, restorations are designed to be performed without the need for an outage or service disruption.

In the same year, 191 towers rated as Condition C, D, and Priority were restored. Without restoration, those 191 towers would have continued to deteriorate, eventually requiring replacement. Rehabilitating those towers in that same year versus replacing them later allowed the utility to avoid more than \$15.3 million in replacement costs!
