Trial by Fire

Protecting Poles Against Growing Wildfire Threat

By David Skinner

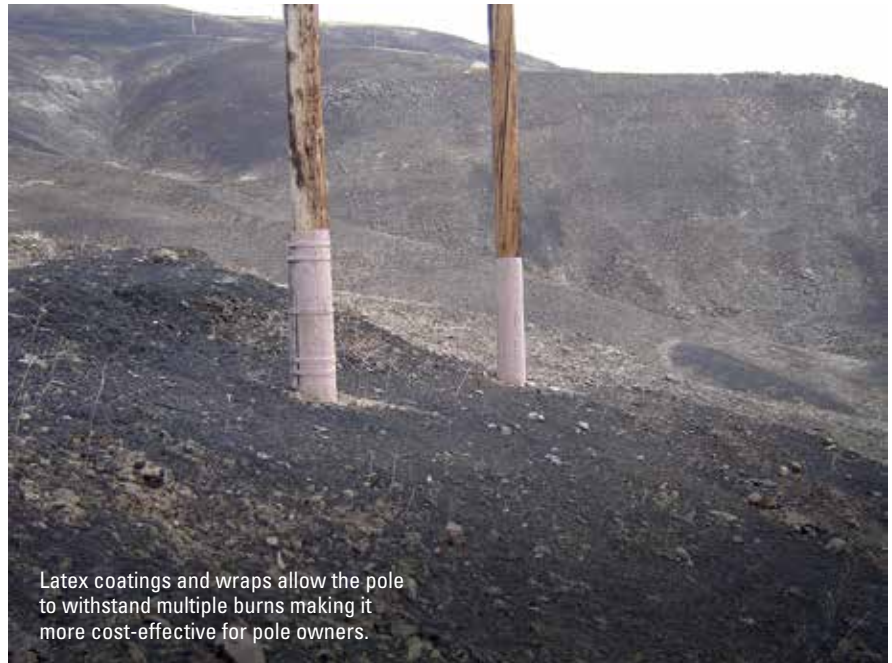
Latex coatings and wraps allow the pole to withstand multiple burns making it more cost-effective for pole owners.

- **Breathable** – An effective product should allow the pole to breathe. Products that do not allow the pole to breathe will encapsulate moisture, promoting decay and subsequently decreasing the service life and safety of the pole.
- **Gaffable** – The product should not render the pole unclimbable, as this can cause problems for linemen who need to ascend the pole for any number of reasons. If the product is not climbable, extra expense will be incurred to install removable steps, and pole owners will need to work through additional safety procedures to perform aboveground maintenance.
- **Long-lasting** – The potential of the product to withstand multiple burns or to be easily repaired in the field makes it more cost-effective for pole owners. Products that are only effective for one burn can be a cost-effective strategy

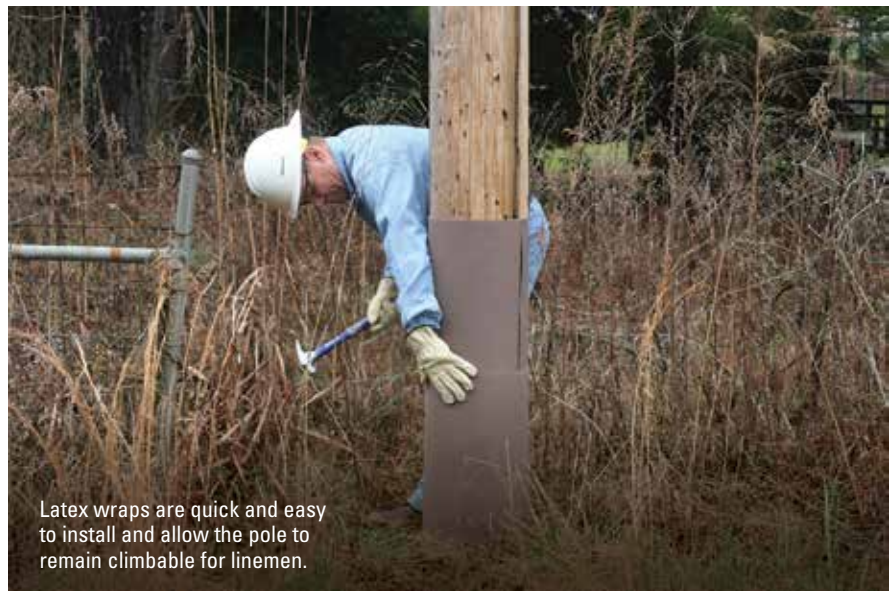
Latex wraps are quick and easy to install and allow the pole to remain climbable for linemen.
